BUREAU OF SHIPS GROUP
TECHNICAL INSPECTION REPORT.

(6) Operation Crossroads, U.S.S. Hughes (DD410)

(11) 1946

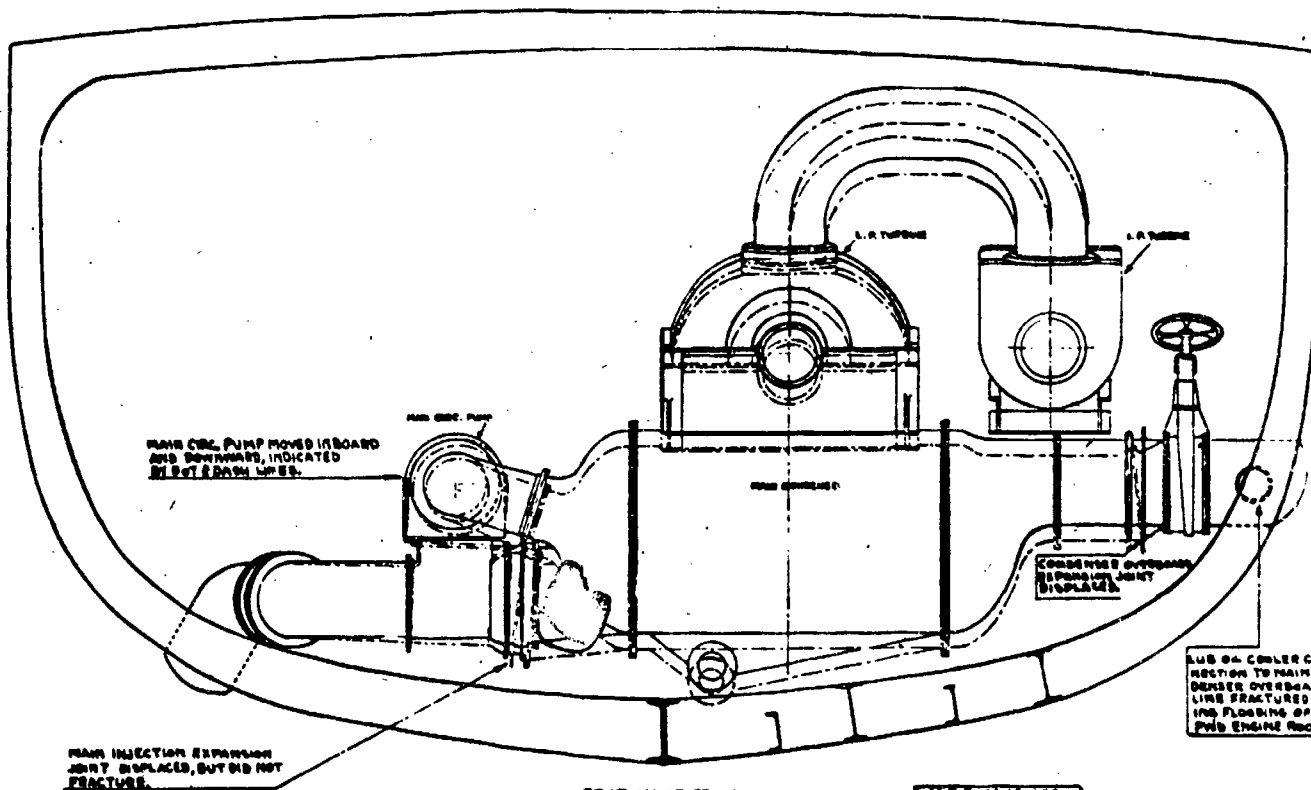
SECTION AT FR. III
LOOKING FOR'D.
SCALE 1/2" = 1 FOOT.

STANDARD LOW PRESSURE TURBINE, LOOKING TO PORT.
SCALE 1/2" = 1 FOOT.

U.S. HUGHES
TEST BAKER
ORIGINAL POSITION
SHOWN IN SOLID LINES.
DISPLACEMENT SHOWN
IN DASH LINES.
FACILITY GROUP
CROSS-SECTION
80-403-31-2.
